**MacArthur Park**  
**Arvada, CO**

Report #: 38656-1  
Beginning: January 1, 2025  
Expires: December 31, 2025

**RESERVE STUDY**  
**Update "With-Site-Visit"**

February 19, 2025

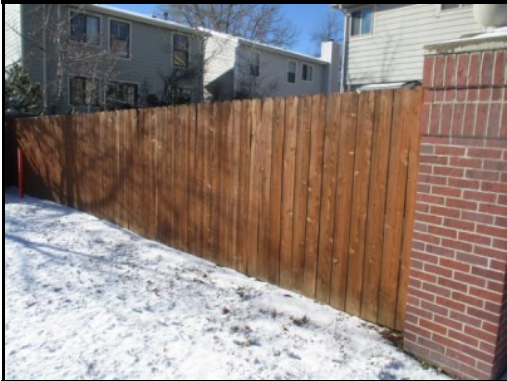
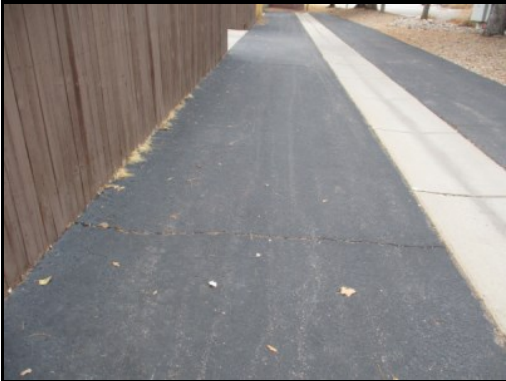
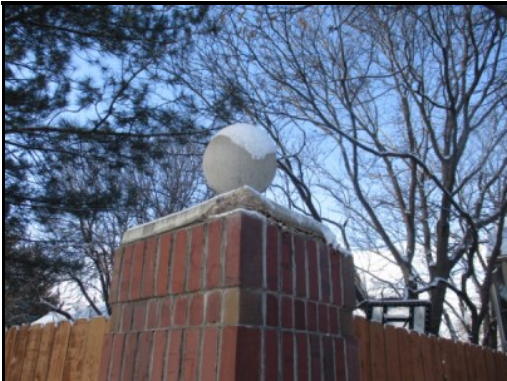
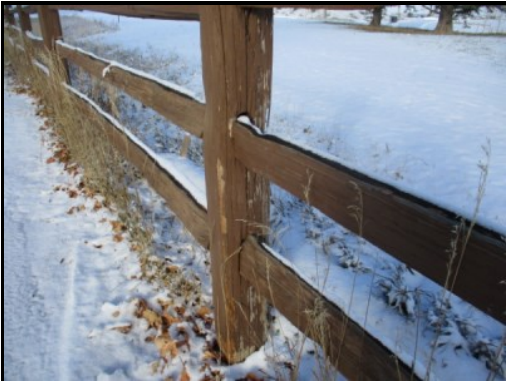
**Site Inspection Notes**

During our site visit on 12/10/2024 we visually inspected the common area assets and were able to see a majority of the common areas. Please see photo appendix for component details; the basis of our assumptions.

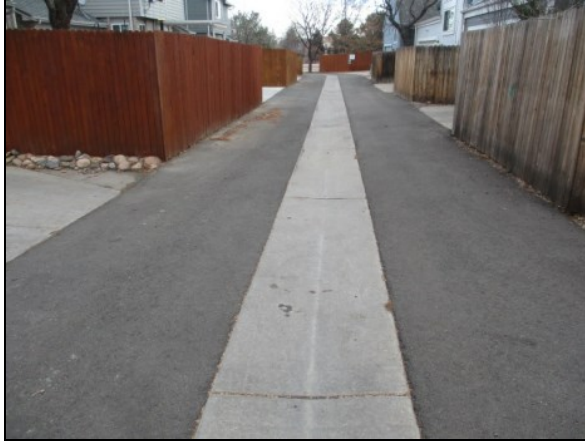
**Comp #:** 21080 Concrete Swales/Pans - Repair - 5%

Comments: The concrete swales and pans were observed to be in fair condition. Minor cracking was noted at the time of the inspection. No heavy damage was seen. Concrete swales are important elements of the site drainage system. Should be inspected periodically to ensure that drainage is not interrupted and any significant cracks or damaged sections repaired in order to maintain a smooth surface. Plan on replacing the swales at the same time as the asphalt removal.

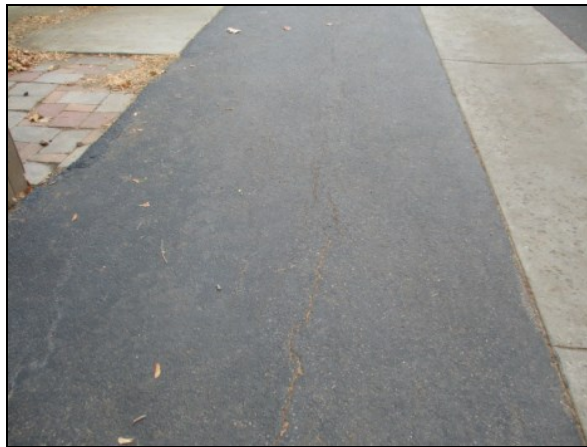
**Comp #: 21190 Asphalt - Seal/Repair**

Comments: Asphalt seal was observed to be in fair condition with no major issues noted at the time of the inspection. Regular cycles of seal coating (along with any needed repair) has proven to be the best program in our opinion for the long term care of lower traffic asphalt areas such as these. The primary reason to seal coat asphalt pavement is to protect the pavement from the deteriorating effects of sun and water. When asphalt pavement is exposed, the asphalt oxidizes, or hardens which causes the pavement to become more brittle. As a result, the pavement will be more likely to crack because it is unable to bend and flex when subjected to traffic and temperature changes. A seal coat combats this situation by providing a waterproof membrane, which not only slows down the oxidation process but also helps the pavement to shed water, preventing it from entering the base material. Seal coat also provides uniform appearance, concealing the inevitable patching and repairs which accumulate over time. Seal coat ultimately extends useful life of asphalt, postponing the asphalt resurfacing, which can be one of the larger cost items in this study (see component #21200 for asphalt resurfacing costs). Repair asphalt before seal coating. Surface preparation and dry weather, during and following application, is key to lasting performance. The ideal conditions are a warm, sunny day with low humidity. Rain can cause major problems when seal coating and should never be done when showers are threatening. Incorporate any striping and curb repair into this project. Fill cracks and clean oil stains promptly in between cycles as routine maintenance. Prior to a seal coat application, the areas will be cleaned with push blowers and wire brooms. Be aware that sealcoat will not adhere to heavily saturated oil spots. Vendors typically recommend infrared patching on areas with saturated oil spots to ensure adherence of sealcoat.

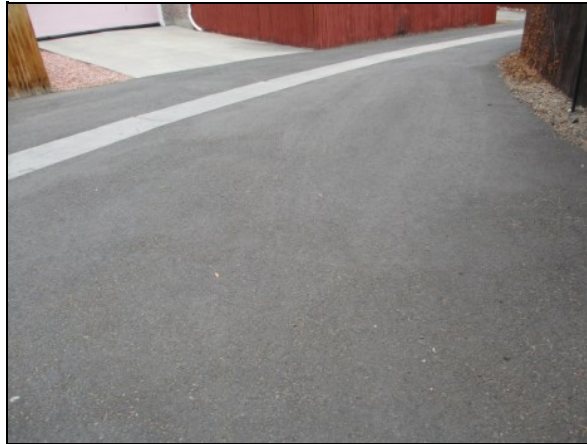
Comments: Asphalt pavement determined to be in fair condition typically exhibits a mostly uniform surface but with minor to moderate raveling and surface wear. If present crack patterns are normal for the age of the asphalt and not extreme and there are no signs of advanced deterioration such as large block cracking patterns "alligating" or potholes. Overall appears to be aging normally and still up to an appropriate aesthetic standard. Useful life below assumes regular seal coating and repairs. The lack of seal coating and repairs can greatly decrease the asphalt's useful life. Resurfacing is typically one of the larger expense items in a reserve study. When need to resurface is apparent within a couple of years consult with geotechnical engineer for recommendations specifications / scope of work and project oversight. As routine maintenance keep surfaces clean and free of debris ensure that drains are free flowing repair cracks and clean oil stains promptly. Assuming proactive maintenance plan to resurface at roughly the time frame below. If regular maintenance and sealing is deferred client may need more extensive repair and replacement projects. Funding below assumes that asphalt has adequate subgrade as well as asphalt fill depth. If fill depth is less than 2" client may need to consider a remove and replacement project which can increase costs by 50% or more. Further resources: Pavement Surface Condition Field Rating Manual for Asphalt Pavement. <http://co-asphalt.com/resources/maintenance-and-preservation/>

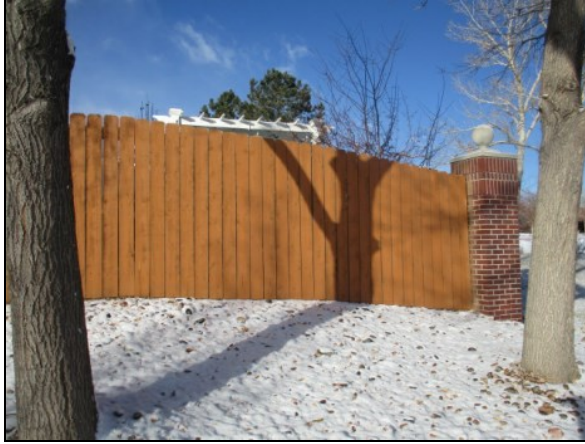
**Comp #: 21320 Site Fencing: Wood - Stain/Paint**

History: Stained and repaired in 2023.

Comments: Wood fencing determined to be in good condition typically exhibits a uniform coating or surface finish with only minor deterioration or color fading. Appearance is consistent over most/all areas and has good curb appeal. Regular uniform, professional paint or sealer applications are recommended for appearance, protection of wood and maximum design life. Repair as needed and clean prior to application. Plan for regular applications as shown below. Timing of repair/paint cycles may need to be coordinated with eventual fence replacement.

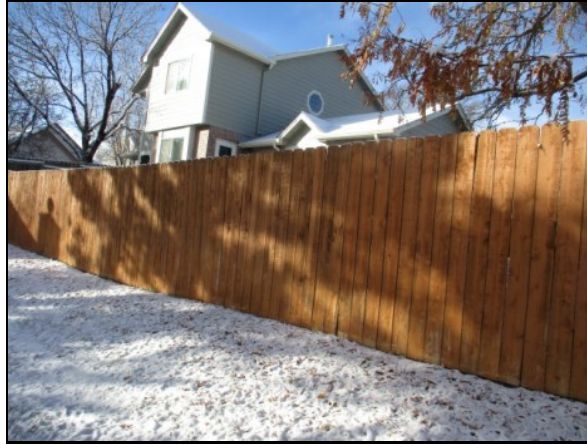
**Comp #: 21330 Site Fencing: Wood - Replace**

History: Replaced in 2016.

Comments: Wood fencing determined to be in good physical/structural condition is stable and upright with no signs or reports of damage or required repairs. All components and hardware appear to be in serviceable condition with no unusual or advanced signs of wear or age. Fencing is in good aesthetic condition. As routine maintenance inspect regularly for any damage repair as needed and avoid contact with ground and surrounding vegetation wherever possible. Regular cycles of uniform professional sealing/painting will help to maintain appearance and maximize life. In our experience wood fencing will typically eventually break down due to a combination of sun and weather exposure which is sometimes exacerbated by other factors such as irrigation overspray abuse and lack of preventive maintenance. Recommendation and costs shown here are based on replacement with similar style and material. However the client might want to consider replacing with more sturdy lower-maintenance products like composite vinyl etc. Although installation costs are higher total life cycle cost is lower due to less maintenance and longer design life expectancy.

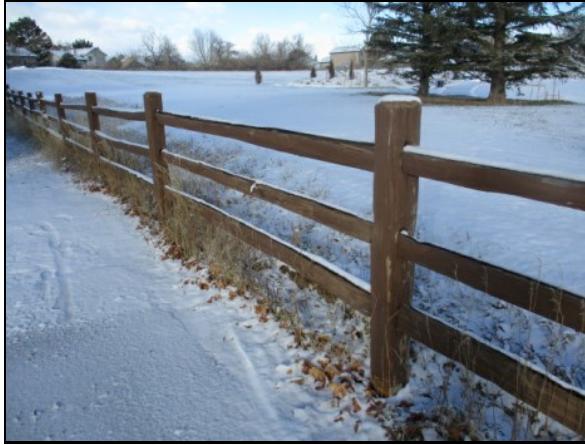
**Comp #: 21340 Site Fencing: Split Rail - Replace**

Comments: Wood fencing determined to be in poor condition typically exhibits more advanced or extensive surface wear and other signs of age which may include damaged or vandalized sections loose or missing hardware and other obvious concerns. At this stage fencing is often an eyesore and replacement from an aesthetic standpoint should be considered even if fencing is still technically upright and intact. As routine maintenance inspect regularly for any damage repair as needed and avoid contact with ground and surrounding vegetation wherever possible. Regular cycles of uniform professional sealing/painting will help to maintain appearance and maximize life. In our experience wood fencing will typically eventually break down due to a combination of sun and weather exposure which is sometimes exacerbated by other factors such as irrigation overspray abuse and lack of preventive maintenance. Recommendation and costs shown here are based on replacement with similar style and material. However the client might want to consider replacing with more sturdy lower-maintenance products like composite vinyl etc. Although installation costs are higher total life cycle cost is lower due to less maintenance and longer design life expectancy.

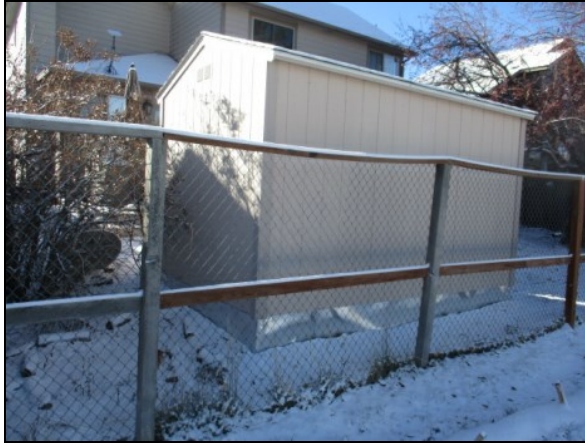
**Comp #: 21360 Site Fencing: Chain Link - Replace**

Chain-link site fencing determined to be in poor condition typically exhibits more advanced signs of surface wear, including rust or corrosion across most surfaces. In some cases, posts may be leaning or bent. Generally unsightly appearance. Chain link fencing generally has lower aesthetic value than other materials, so remaining useful life is mostly based on structural conditions, although appearance is also considered.

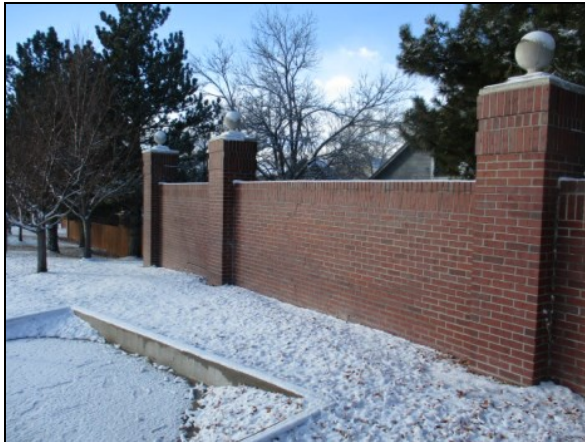
Comments: At this time costs related to this component are expected to be included in the client's Operating budget. No recommendation for Reserve funding at this time. However any repair and maintenance or other related expenditures should be tracked and this component should be re-evaluated during future Reserve Study updates based on most recent information and data available at that time. If deemed appropriate for Reserve funding component can be included in the funding plan at that time.

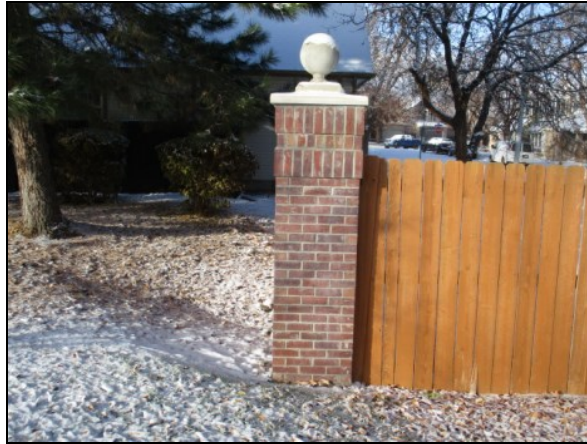
**Comp #: 21400 Pillars – Repair/Replace**

Comments: Includes approximately (47) 2'x2'x8' high stone pillars topped with a decorative cap. Inspect regularly repair as needed from Operating budget. If shifting cracking etc. are observed consult with civil or geotechnical engineer for repair scope. At this time no expectation of large scale repairs or replacement no Reserve funding recommended. An allowance for partial repairs/replacements may be added during future Reserve Study updates if warranted by client history.

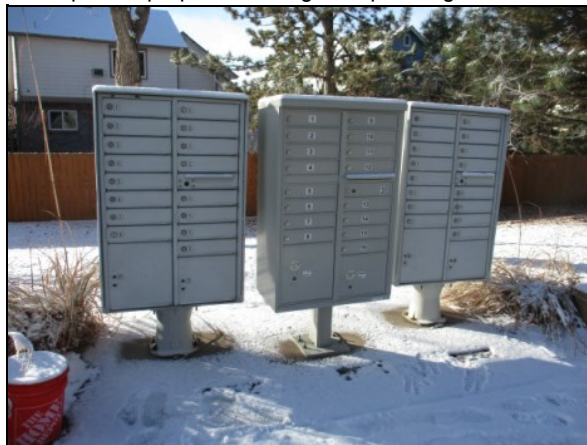
**Comp #: 21600 Mailbox Kiosks - Replace (Ph 1)**

History: Replaced in 2021.

Comments: Mailbox kiosk determined to be in good condition typically exhibit a uniform appearance without much surface wear. Hardware appears to be in good condition, and boxes/panels appear to close and lock properly. Appearance and style are consistent with the aesthetic standards of the development. Inspect regularly, and clean by wiping down exterior surfaces. If necessary, change lock cylinders, lubricate hinges and repair as an Operating expense. Best to plan for total replacement at roughly the time frame below due to constant exposure, usage and wear over time. Note USPS has a limited budget for replacement and should not be relied upon for purposes of long term planning.

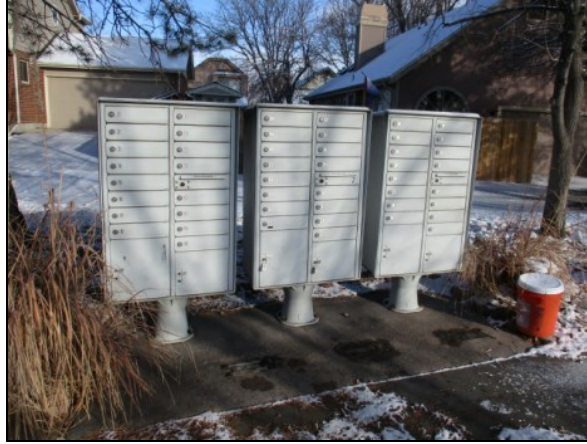
**Comp #: 21600 Mailbox Kiosks - Replace (Ph 2)**

Comments: Mailbox kiosks determined to be in fair condition typically exhibit minor to moderate surface wear at this stage. All components and hardware appear to function properly but appearance is diminishing. Inspect regularly and clean by wiping down exterior surfaces. If necessary change lock cylinders lubricate hinges and repair as an Operating expense. Best to plan for total replacement at roughly the time frame below due to constant exposure usage and wear over time. Note USPS has a limited budget for replacement and should not be relied upon for purposes of long term planning.

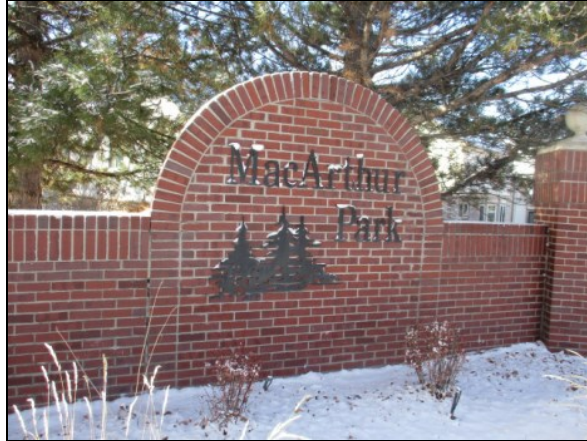
**Comp #: 21610 Sign/Monuments - Refurbish/Replace**

Comments: Includes metal signage on the brick walls on the north and south sides of the Kipling Street and Kline Street entrance. Monument signage determined to be in fair condition typically exhibits acceptable appearance and aesthetics in keeping with local area, but with more weathering and wear showing on surfaces. If present, landscaping and lighting are still in serviceable condition. At this stage, signage may be becoming more dated and diminishing in appeal. As routine maintenance, inspect regularly, clean/touch-up and repair as an Operating expense. Plan to refurbish or replace at the interval below. Timing and scope of refurbishing or replacement projects is subjective but should always be scheduled in order to maintain good curb appeal. In our experience, most clients choose to refurbish or replace signage periodically in order to maintain good appearance and aesthetics in keeping with local area, often before signage is in poor physical condition. If present, concrete walls are expected to be painted and repaired as part of refurbishing, but not fully replaced unless otherwise noted. Costs can vary significantly depending on style/type desired, and may include additional costs for design work, landscaping, lighting, water features, etc. Reserve Study updates should incorporate any estimates or information collected regarding potential projects.

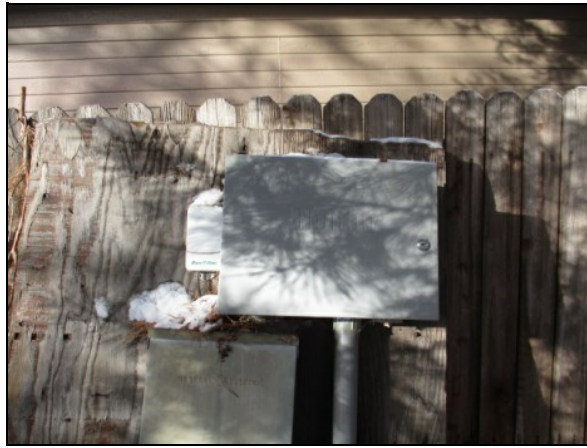
Useful Life:  
15 years

Remaining Life:  
4 years

Best Case: \$ 1,900

Worst Case: \$ 2,800
